Abandoned Mine Reclamation Program PROJECT SUMMARY

Mohrland Culvert Maintenance Emery County, Utah

AMR/015/931

Mohrland Culvert Maintenance, 2017 -- Construction Summary

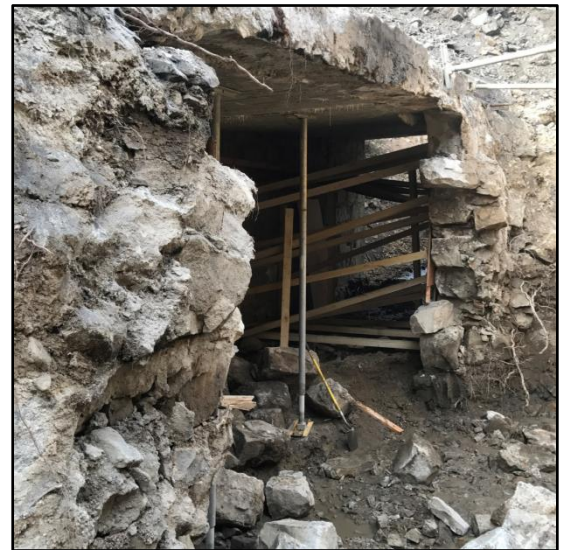
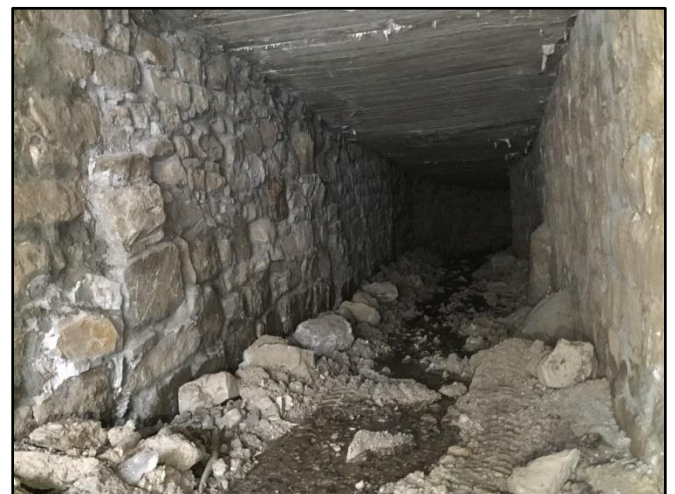
Above: (Pre-construction) Partially collapsed culvert wall
Below: (Post-construction) Repaired culvert wall

The purpose of this project was to repair the partial collapse of a historic stone culvert located at the Mohrland Mine. In order to complete the repair, over 350 cubic yards of material was first removed to expose the stone culvert wall. Next, the collapsed stone was hoisted out of the trench and stockpiled on-site to provide a sufficient working area for the crew. The culvert could then be shored and braced to prevent further collapse. Following stabilization, the stone was hoisted back into the trench, chiseled and cut as needed, and the wall carefully rebuilt by a skilled mason in order to preserve the cultural integrity of the site. A 28 cubic yard cement retaining wall was then poured, using the stone wall as the inside form. The retaining wall was allowed four days to cure and then the trench was backfilled with the excavated material. A perforated PVC and gravel drain was also installed in the trench to stimulate drainage into the culvert.

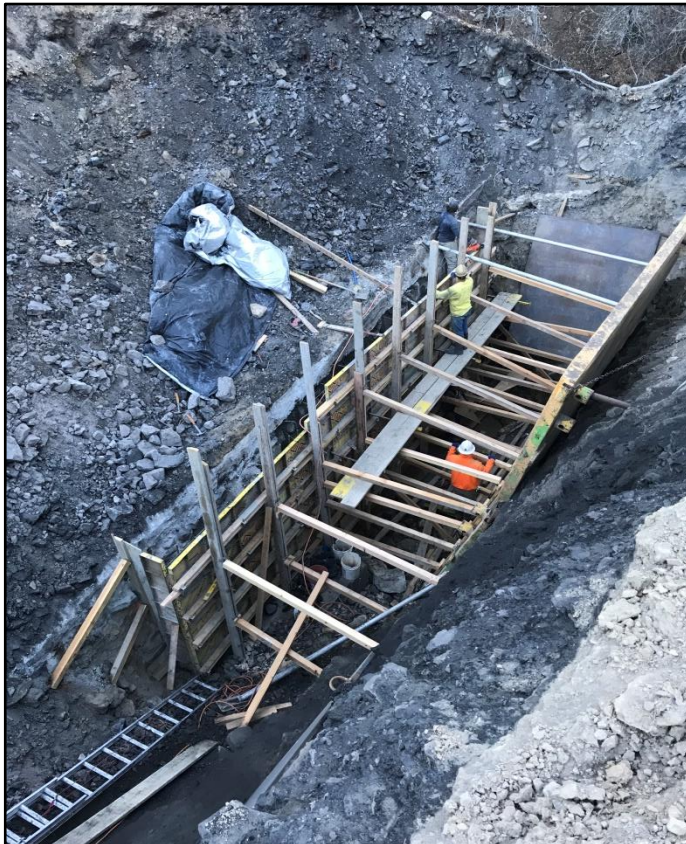
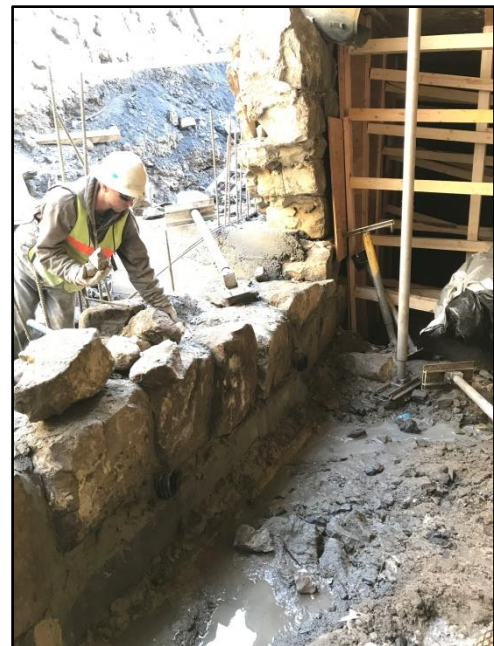
Above: Stone mason fits cut native stone into wall, taking care to preserve cultural integrity
Left: Form and shoring in-place for cement retaining wall
