# Abandoned Mine Reclamation Program PROJECT SUMMARY

## DUTCH MOUNTAIN PROJECT (2013 Private Sites)

Tooele County, Utah

AMR/045/919

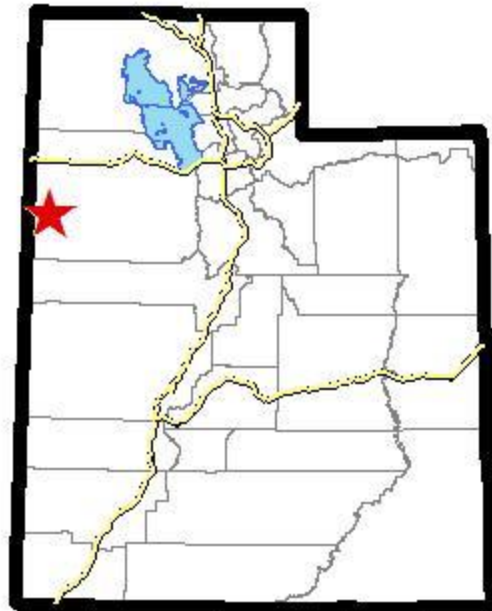
**Left: Dutch Mountain site 3071823HO001 before and after backfill closure.**

CRC Construction of Salt Lake City was selected as contractor for the project using the Job Order Contract procurement process. CRC Construction subcontracted the mine closure work in its entirety to The Xcavation Company. The work at the site consisted of hand backfill of the three Dutch Mountain sites and repair of six vandalized closures at Gold Hill (replacement of two rock walls with concrete block walls and reinforced concrete, repairing a damaged bat gate and two rebar shaft grates, and refilling a backfill. Repair of a breached stone wall at Gold Hill site 3071731HO011 was deleted from the work when it was discovered late in the process that it was on a recently staked unpatented claim and there was not time to acquire claimant consent.

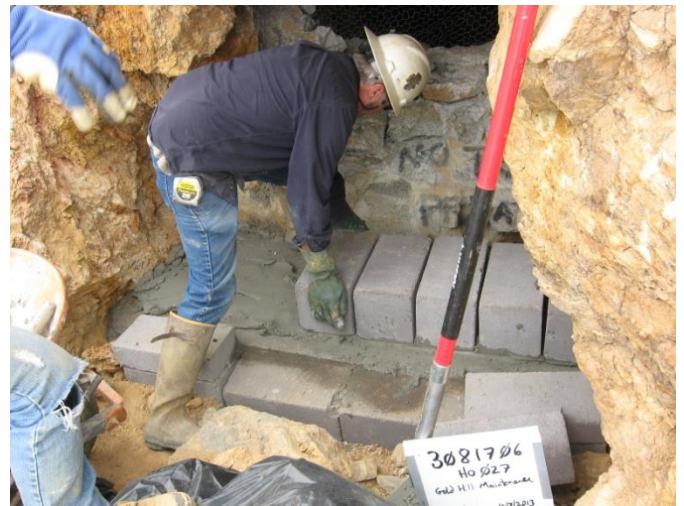
**Right: (Top)** Construction of concrete block wall outby the vandalized stone wall at Gold Hill site 3081706HO027.

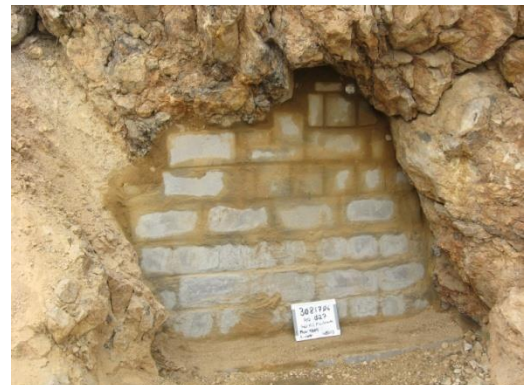
**(Bottom)** Completed block wall.

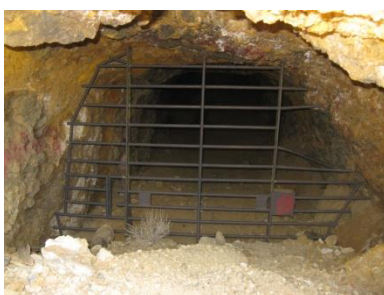
**Below: (Left)** Vandalized bat gate at Gold Hill site 3081706HO026. **(Right)** Bat gate re-anchored, patched, and reinforced.
